# CARDONE™ ProTech®

## Ford Power Steering Noise Caused by Pulley Position

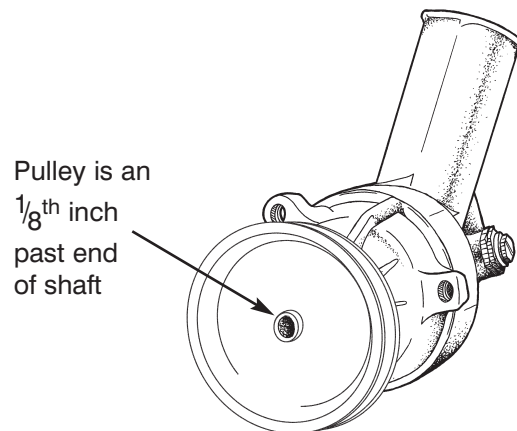
**Problem** Noisy power steering pump operation not attributed to air in the system.

**Cause** The belt pulley may not be pressed on the shaft in the proper position. Side loading from the misaligned pulley forces internal parts to rub, causing noisy operation.

**Solution** Make sure the pulley is pressed on 1/8th inch past the end of the shaft as shown below. Proper pulley alignment is critical for all applications. Always replace bent or damaged pulleys.
