# CARDONE™ ProTech®

## Power Steering Leak At Pressure Feed Tube Or Union

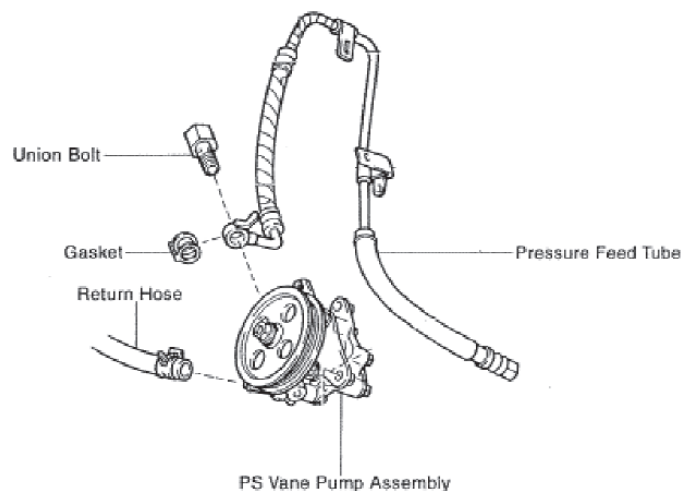
### Typical Installation

**Problem** Leaks at pressure tube or fitting union after replacing hose or servicing the power steering pump.

**Cause** Seal between the hose and fitting has failed due to a dirty or damaged sealing surface, gasket damage or reuse of the old gasket.

- Solution**
1. Always use a new gasket at the banjo fitting.
  2. Be sure that the sealing surface of the fitting on the pump is clean and that it is not deformed from its original condition. Even a small nick on the sealing surface could cause a leak.
  3. Torque the union bolt to the recommended repair torque (typical 52 Nm, 38ft.lbs. – refer to vehicle service manual for specific torque).
