# CARDONE™ ProTech®

## Ford Power Steering Noise Caused by Pulley Position

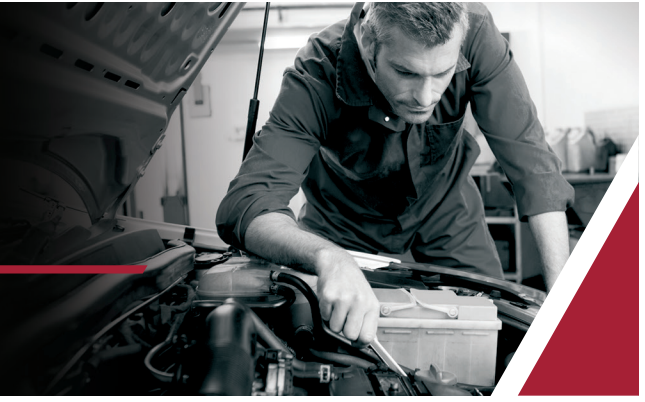
**Application** All vehicles equipped with Ford C2 style pumps (typical unit shown below with aluminum housing and plastic reservoir).

**Problem** Noisy power steering pump operation not attributed to air in the system.

**Cause** The belt pulley may not be pressed on the shaft in the proper position. Side loading from the misaligned pulley forces internal parts to rub, causing noisy operation.

**Solution** Make sure the pulley is pressed on 1/8th inch past the end of the shaft as shown below. Proper pulley alignment is critical for all applications. Always replace bent or damaged pulleys.
