CARDONE™ ProTech®

Improper Placement of Fitting O-ring Results in No Pressure

Application All vehicles equipped with power steering.

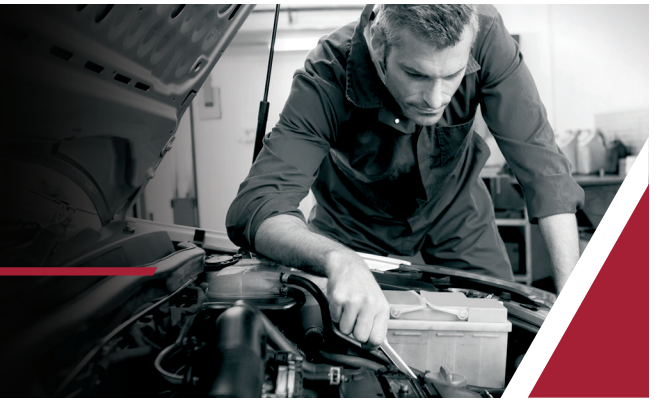
Problem No pressure output from power steering pump after installation of a new O-ring on the power steering pressure fitting.

Cause Incorrect placement of O-ring on the pressure fitting, blocking the flow of fluid from the bypass hole to the flow control valve. This causes a no-pressure condition.

Solution Install the replacement O-ring in the correct position on the fitting. Also make sure piston is moving freely in bore, a stuck piston will cause the same problem.
